## Steel plant transformer operational issues

**Abstract.** Design of steel-plant furnace three-phase transformer (110 kV/(350 to 500) V, 50 kA) and its operating conditions are described in the paper. After three months of operation this transformer failed. Cause of failure, its course and damage to transformer winding are presented. Recommendations for transformer winding design and its installation and protection are given.

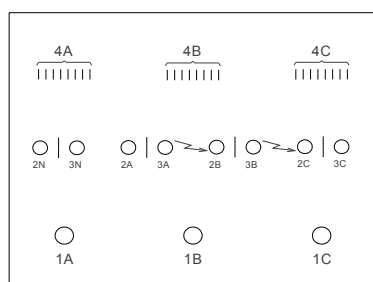
The investigated transformer was brand new when it was installed and put into operation in July. The failure occurred in October, so it operated only three months. The failure took place during switching the transformer from no-load state to on-load operation. When switch Q1 was closed, emergency cut-off took place, via power switch Q1 installed on the switchboard. The QS1 switch was tripped after 70 ms has passed. The gas-filled protection was also actuated (this breaker constituted the second stage of transformer protection) as well as protections on both medium tension (SN) windings. The surge limiters installed at both sides of Q1 breaker did not operate. The short-circuiting switch 4KM was on and cable connecting low tension winding (DN) with the short-circuiting switch was burned out (gone). The transformer operated in shorted circuit. The bushing insulators were burned and completely damaged by electric arc.

Fig. 2. View of transformer tank cover; locations of bushing insulators and arcing faults are marked

Electric arc occurred between insulators 3A – 2B and 3B – 2C, as shown in Figure 2. Traces of burning by electric arc were also observed at DN winding leads. This arc caused three-phase arcing fault of main transformer SN winding. The measurements conducted sometime after the failure showed that main transformer SN winding had been damaged. The chromatographic tests of gases dissolved in transformer oil and gases obtained from gas-flow relay showed existence of internal short-circuit in the transformer.

- to set up second interlocking between circuit breakers Q1 and 4KM, eg. based on current measurements in holding coils of Q1 and 4KM breakers (obligatory measure),
- to connect earthing cable to DN (low tension) current cables outside the chamber; short-circuiting switches 3KM and 4KM should be installed outside the chamber (obligatory measure),
- high tension winding W1 should be manufactured for rated voltage equal to 120 kV,
- taps of control winding W2 should be distributed along the column height (as shown in Fig. 4); the clamping of moulding Elkon rings should be changed from point-wise to surface-wise; the ring holding should be strengthened (thickened),
- transformer chamber should be sealed, air-blast should be introduced and chamber pressure kept at all times above the ambient (manufacturing room) pressure (obligatory measure).

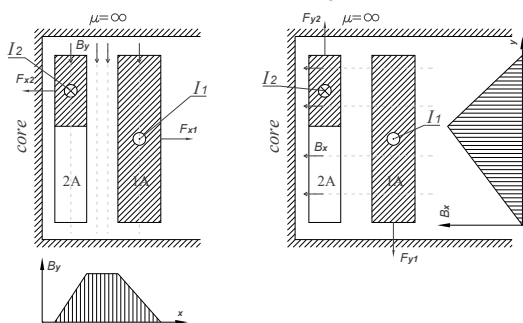
The control winding W2 has been designed with taps. When tap is connected into the circuit, only part of the winding operates and it is placed non-symmetrically in the column in relation to primary winding W1 (Fig. 3). This asymmetry is particularly significant in case of tap No.1. This tap was connected during the investigated short-circuit event.

During second stage of short-circuit, the ampere turns of W1 and W2 windings were equal to each other, this may be concluded from theory of transformers [2,3]. The said asymmetry generates magnetic fields in transformer window: longitudinal field  $B_y$  and transverse field  $B_x$ . The interaction of these fields and windings current produces electrodynamic forces, this is shown in Figure 3. Figure 3 is of course only a model illustrating generation of forces  $F_x$  i  $F_y$ , and in particular axial force  $F_y$  which became the destructive force. The  $F_y$  might be smaller if the active part of W2 control winding at each tap was distributed uniformly along the column height, since the  $B_x$  flux density component is then minimum (see Fig. 4).

Fig. 3. Active parts of transformer #1 (marked) during the short-circuit-event; directions of electrodynamic forces are shown and distribution of flux density in transformer window

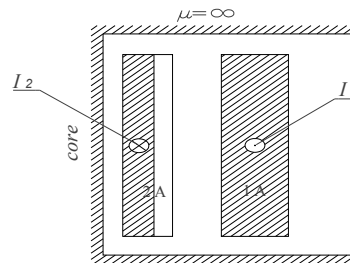
Fig. 4. Correct execution of transformer #1 control winding
