Thermovision in Distribution Power Networks

Abstract. The paper deals with the use of thermography in distribution power networks. It focuses on the complications of using thermography in normal operation and shows the results of regular measurements of individual parts and units of distribution networks. The paper is concerned with the processing and assessing a large database of thermovision measurements.

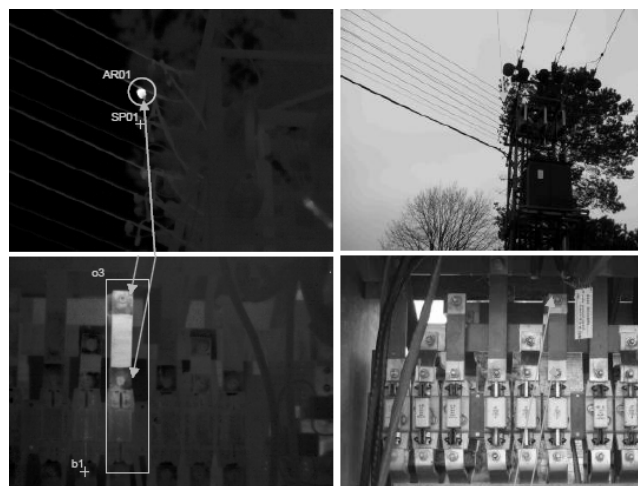
Fig. 1. Examples of detected defects

Firstly, MS Excel was used for creating database tables containing assorted and grouped information. Then, contingency tables were used for further adjustments, see [4]. As an example below - Fig. 1 presents individual groups: a damaged anchor clamp of an overhead line and a loose screw on a busbar.

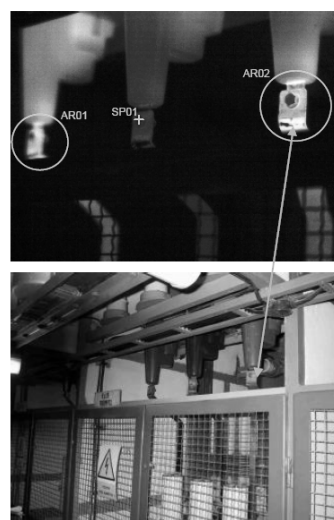
Finally, Figure 2 is an example of a thermovision check of an interior 22 kV substation where a defect was detected because of warming of the clamp of the measurement transformer.

Fig.2. Warmed connector of a measurement transformer in the interior 22 kV substation

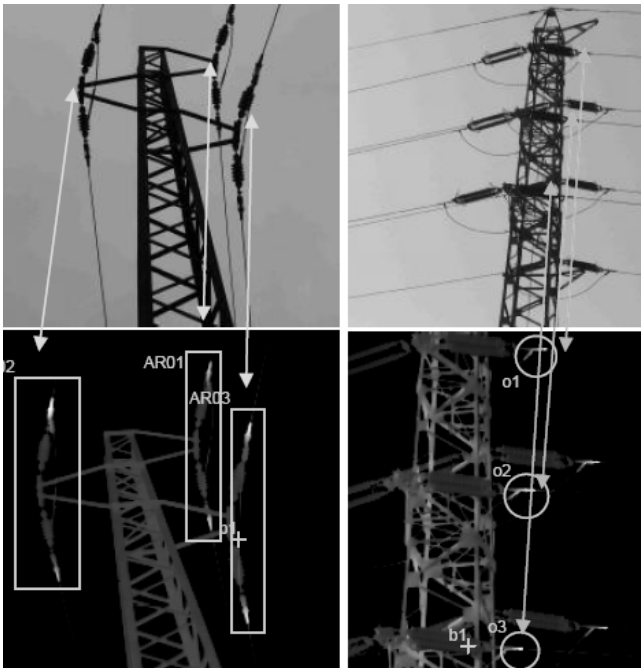
In Figure 3 there is an example of an MV line on the left and an HV line on the right, both with warmed clamps.

Fig.3. MV and HV transmission tower designs with warmed gun type clamps

The total evaluation for 110 kV lines is given in Table 6, which shows the most problematic parts on the HV lines with gun type clamp at the top (see Figure 3). It is a clamp used for lines interconnection between the poles and between the suspensions of insulators. There were also problems with the bushings and finally, with the conductor itself.
