Symmetrically broken rotor bars effect on the stator current of squirrel-cage induction motor

Abstract. End rings and broken rotor bars are common faults in squirrel cage induction motors. For this purpose various broken rotor bars would have been obtained on a special designed rotor of a squirrel cage induction motor. Desired real current data of the broken bars through rings and brushes special designed a squirrel cage of induction motor have been measured. In this study, a three-phase with special designed rotor of a faulty squirrel cage induction motor have been run under nominal load. Stator current wave form analysis has been obtained. This obtained data are compared with stator current of the healthy condition of the rotor bars. The effects of the faults over the stator currents are investigated.

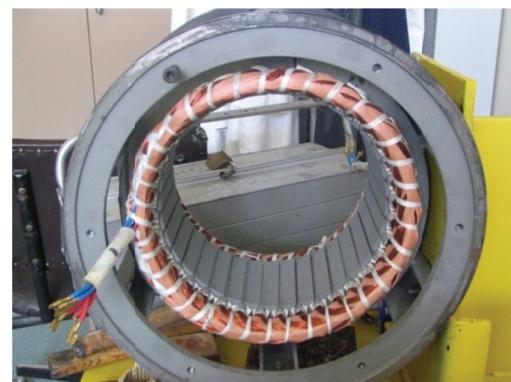
Fig.1 Depiction of the special designed induction motor stator part

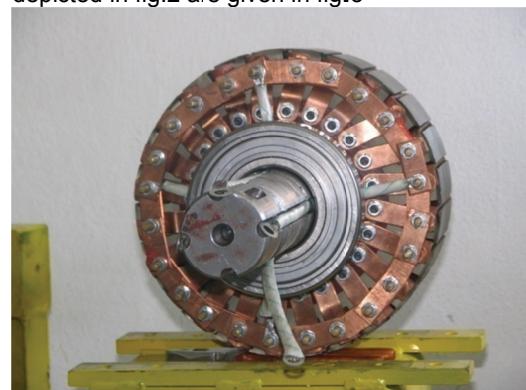
Fig.2 Depiction of the special designed rotor

Equivalent circuit diagrams both healthy and faulty condition of the special designed induction motor rotor is depicted in fig.2 are given in fig.3

Equivalent circuit diagrams are given in fig.3 both and Faulty condition of the special designed induction motor rotor is depicted in fig.2.
