Fire hazard in EX Zones caused by lightning protection system tested according to EN 62561-1

Abstract. The article presents the results of studies on the effects of lightning current through various types of lightning cross connectors forming a comprehensive lightning protection system. The tests were conducted to demonstrate that the H class current described in EN 62561-1 for protection level I is insufficient to adequately assess the suitability of the connector for use in an explosive atmosphere where it may be a source of ignition of the explosive atmosphere. (**Zagrożenie pożarowe powodowane przez system ochrony odgromowej badany zgodnie z normą EN 62561-1**).

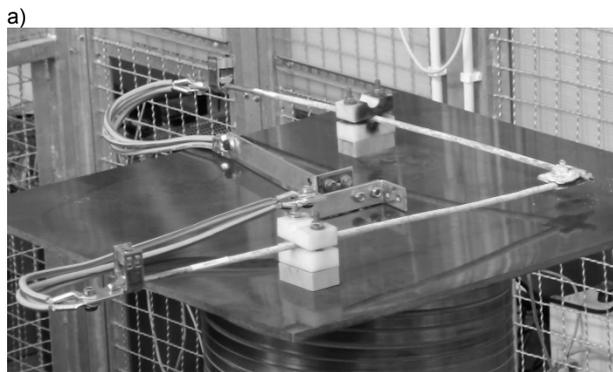
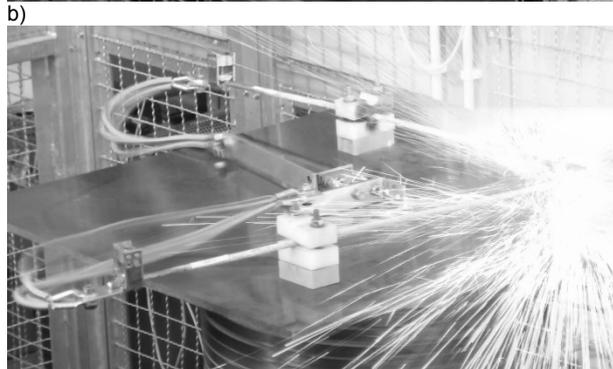
Fig. 4 Cross connector before the tests (a) and during the test (b) with 100 kA current and shape 10/350 μ s

During the tests the performance of different protective connectors subject to exposure by lightning current at peak value of 100 kA was observed. The test was being recorded by the video camera. Photos 4-9 depict freeze-frames from the film which was shot while conducting the research. The first photo depicts the sample before the test and the second one - afterwards.

During the research with all types of tested connectors thermal sparking was observed during surge current flow (equivalent to the first lightning discharge) at a peak value of 100 kA and shape 10/350 μ s. The scientific test stand was positioned 1.5 m above the ground level. The falling sparks had an impact within the radius of 1.5 m from the connector. Additionally the sparking triggered a significant sooting of the board to which the tested elements were attached. In many instances the protraction of the cable from the connector was also observed.

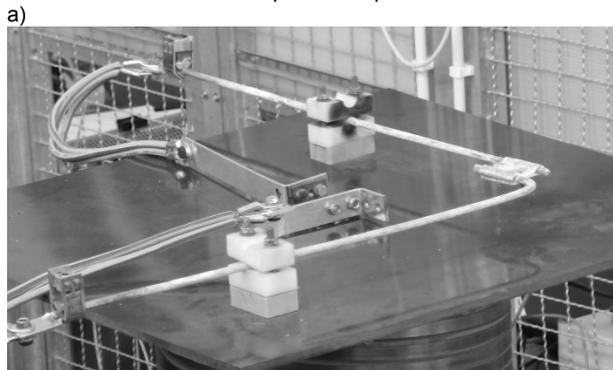
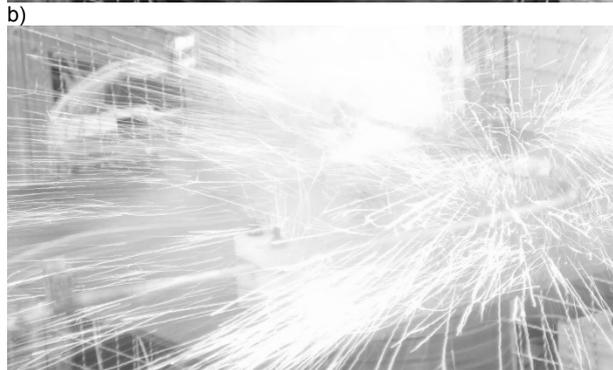
Fig.5 Through connector before the tests (a) and during the tests (b) with 100 kA current and shape of 10/350 μ s

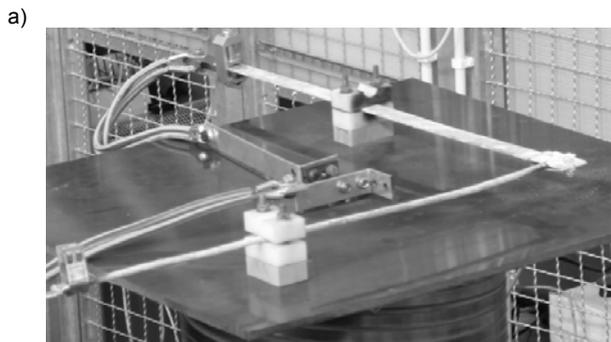
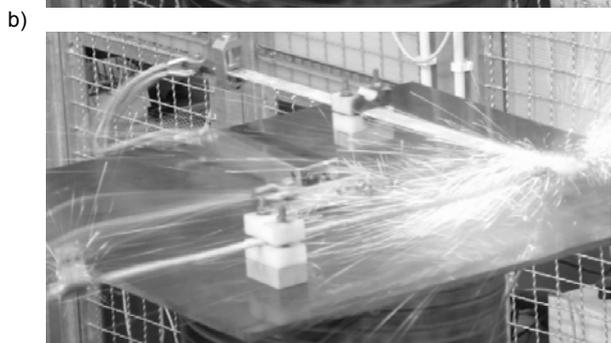
Fig. 6 Cross flat connector before the test (a) and during the test (b) with 100 kA current and shape 10/350 μ s

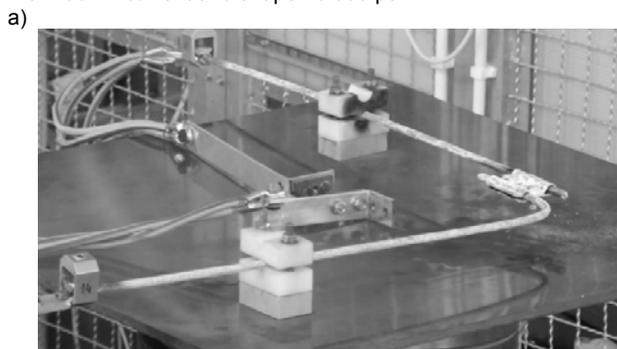
Fig. 7 Through galvanised connector before the test (a) and during the test (b) with 100 kA current and shape 10/350 μ s

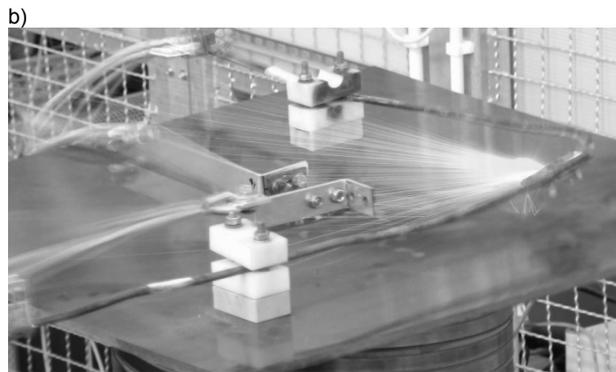
Fig.8 Through copper connector before the test (a) and during the test (b) with 100 kA current and shape 10/350 μ s

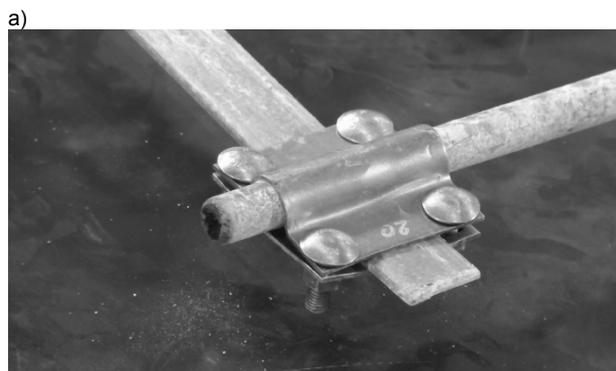
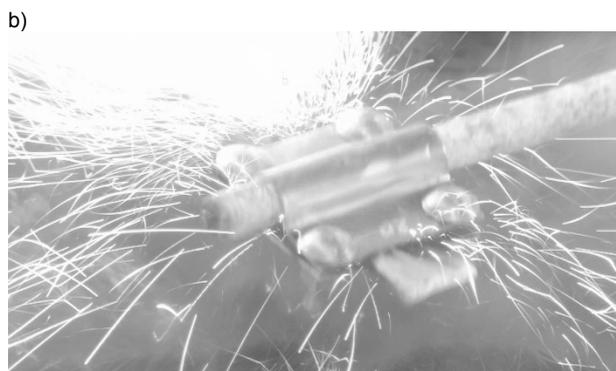
Fig.9 Cross connector assembled before the test (a), during the test (b) with 100 kA current and shape 10/350 μ s
