Voltage withstand tests and PD measurements on cable accessories with assembly mistakes

Abstract. The paper presents the results of voltage withstand tests and partial discharges measurements made on MV cable accessories made with assembly errors. The tested equipment was subjected to tests developed according to its own program on samples from different manufacturers. The paper presents the results of the discussed tests compared to the prepared reference equipment.

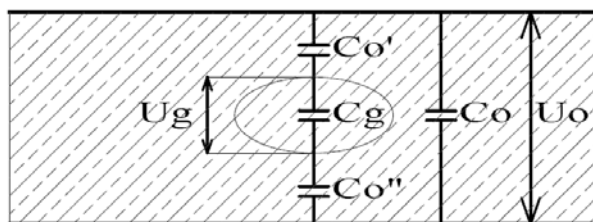
Fig.1. A simplified substitute diagram of the dielectric system, where: C_o - the capacity of the tested object, C_g - a volume of gas inclusion, C_o' , C_o'' - the volume of newly formed parts of the permanent discharge dielectric

One should mention, that partial discharge source may be improper layers assembly for paper insulation or gas inclusions, shown on the simplified diagram in Figure 1.

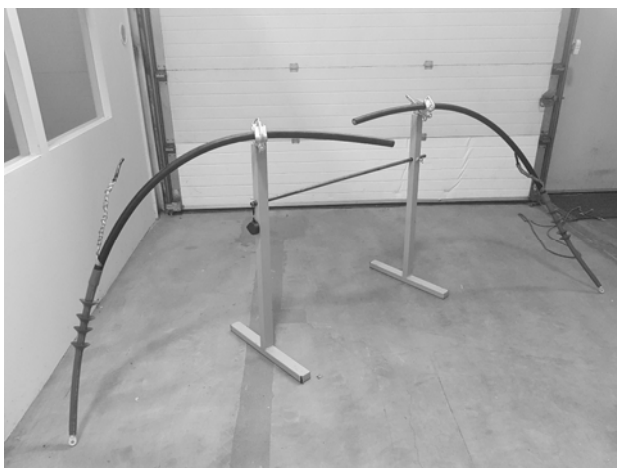
Fig.2. Preparation of the test specimens: cable before an assembly of the tested joints and after PD measurements

Main test objects were cable joints. For this reason, before the assembly of cable joints, specimens with an outdoor termination on both sides were prepared and the level of partial discharges was measured on them. In any case, the level of partial discharges with mounted outdoor terminations did not exceed the background level equal to 2 pC. After that, the specimens were cut in the middle and reconnected with the tested cable joints. This allowed stating that the measured level of discharges comes mainly from the joints and not from the rest of the test samples.

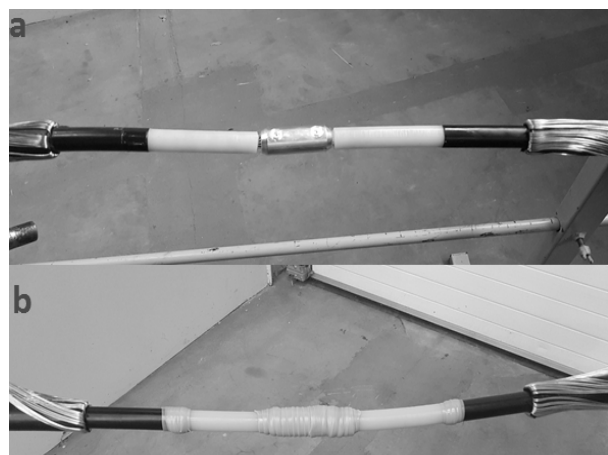
Fig.3. Preparation of the test specimens: a) connector before and b) after assembly of stress control mastic for test specimen No. 1

Figure 3 is showing the assembly process of electric field control tape. In samples without this solution, the mastic for controlling the electric field was not installed. The remaining samples were made identically to the ones shown.

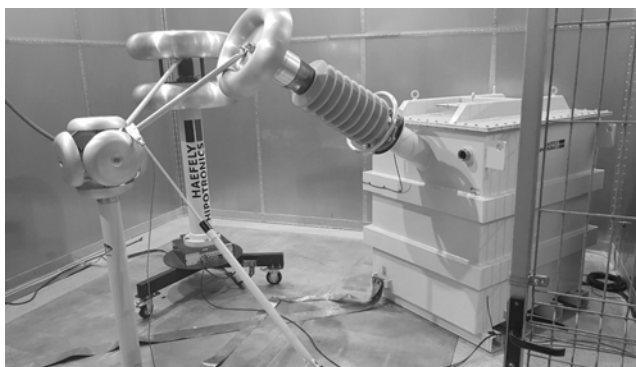
Fig.4. A view of the stand for measuring the level of PD

measurement impedance LDM-5/U – Doble Lemke, and digital measuring system for measuring the level of partial discharge PD Smart – Doble Lemke. The electric diagram of the measurement system is shown in Figure 5, and the view of the measurement stand is shown in Figure 4.

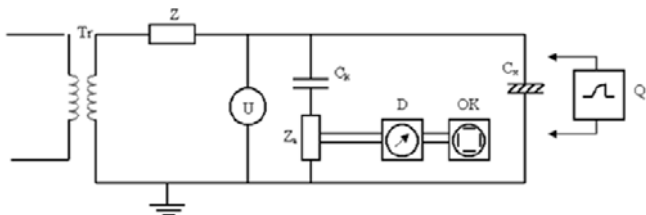
Fig.5. Diagram of a PD test and measurement system; where: Tr – TP150 kV test transformer, Z – supply impedance, U – voltage measurement on the control and measurement unit, C_k – coupling capacitor, Z_s – impedance, D – PD SMART analyzer, OK – PC computer with software for visualization of test results, C_x – a test object [3]

The test and measurement system consisted of Haefely Hipotronics devices: a separation transformer 400/400 V, a voltage regulator, a low-pass filter, a test transformer up to 150 kV, a capacitive voltage divider, a coupling capacitor, a

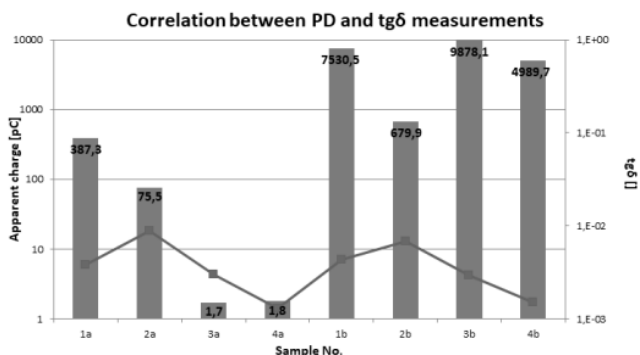
Fig.7. Correlation between partial discharge and dielectric loss measurements; blue – PD, red – $\tan\delta$

Figure 7 shows the relationship between PD measurements and $\tan\delta$ results from tests.

As can be seen, the results obtained during PD and $\tan\delta$ measurements are not convergent. The high value of partial discharges is not always identical with the increased dielectric loss factor.

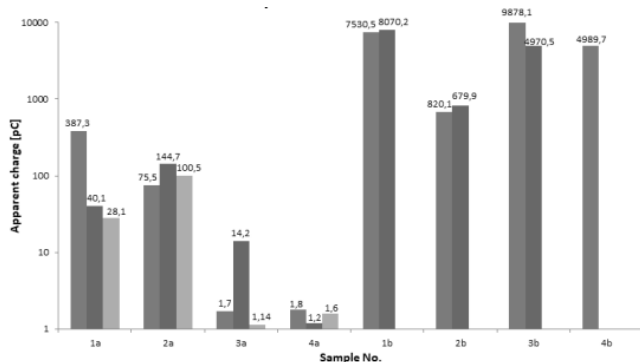
Fig.8. Comparison of all measurements of partial discharges carried out in the interval of time; blue – before all tests, red – after all tests, green – about 30 days after all tests

During the tests, it was confirmed that PD measurements should not be made immediately after the assembly of the test specimens, because due to the construction of the samples, the measurement results are not reliable. Diagrams 8 and 9 are showing confirmations for this conclusion.

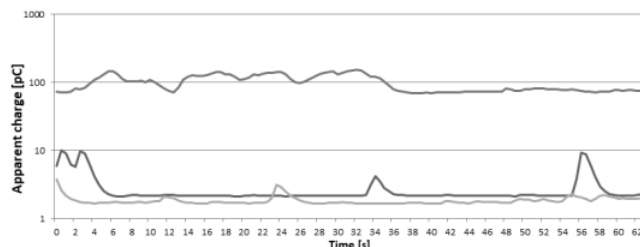
Fig.9. Comparison of all measurements of partial discharges made in the interval of time on an example; blue – 1st measurements, red – 2nd measurements, green – 3rd measurements
