Głogów pollution test station, a review of 30-years research

Abstract. Insulators made of different materials were tested: porcelain, glass, hydrophobic glazes, silicone rubber, hydrophobic epoxy resin and polymer concrete. Special attention was paid for tests of insulators that have a different specific leakage distance. The leakage current and flashovers were monitored and the degree of pollution on the insulator surfaces was sampled on different insulators with the same profile but made of different materials. It was found that a shorter specific leakage distance than that recommended by the IEC 60815 standard is possible.

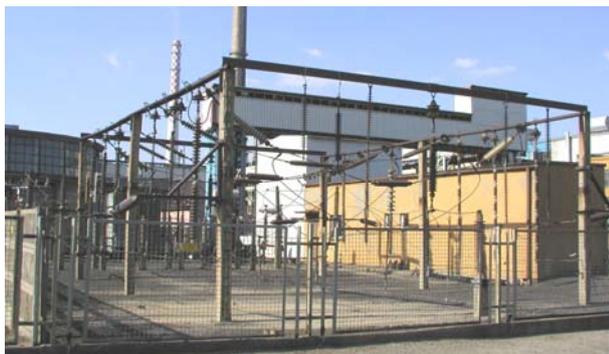
Fig.2. Insulator field, the small (yellow) building contained a 6 kV substation and the command room, the white cubic room housed the pollution chamber.

Severe contamination in the Legnica-Glogow Copper Region caused pollution flashovers on outdoor insulation in the winter of 1978/1979. As a result, the new modern pollution test station was built in 1980 at the so-called Glogow I Copper Smelting Plant. The station was supplied through a 2 MVA power transformer manufactured by TUR Dresden, which delivered the adjustable voltage from 0 to 200 kV. The main source parameters are as follows: nominal current 10 A, voltage 6/200 kV, power 2 MVA, short circuit voltage 8.5%, and short current 150 A. The power is delivered through three transformers: the symmetry transformer ESDOM 6/1 kV (supplied by three 6 kV phases), the regulation transformer FT/D/EO 1000/10 AL, and the high voltage transformer 6/200 kV. The insulator field and the three transformers are shown in Figures 2 and Figure 3.

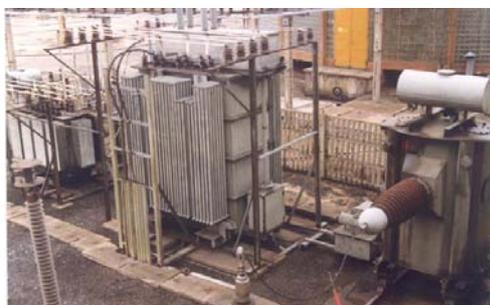
Fig. 3. Supply transformers. From left to right: the symmetry transformer (supplied by three 6 kV phases), regulation transformer and high voltage transformer 6/200 kV.
